Trouble-Shooting Plan

Danger of Accident on Semi-conductor Ignition Systems

VDT-I-227/102 B

EFFECTS OF ELECTRICAL AND ELECTRONIC
SYSTEMS ON HEART PACEMAKERS

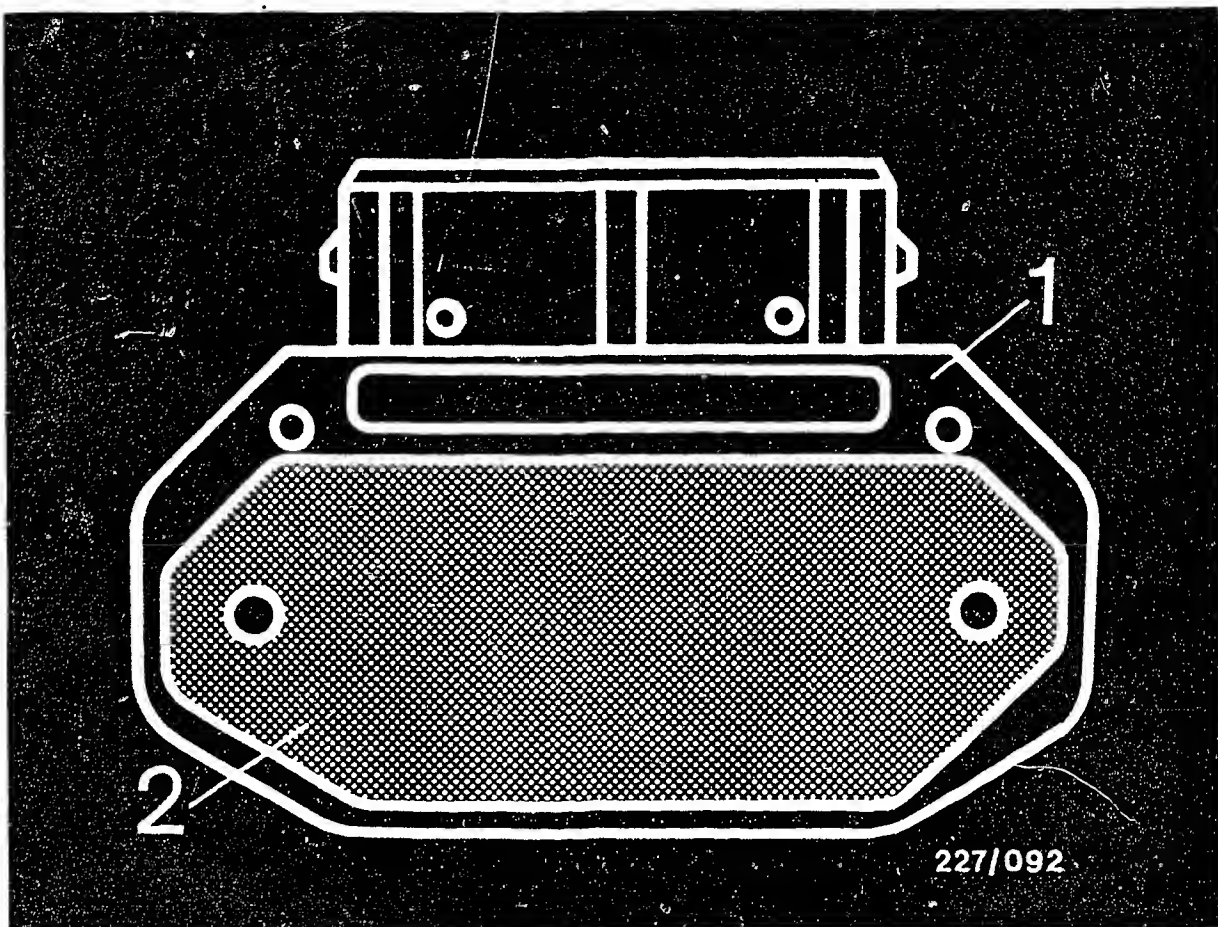
1 = Trigger box
2 = Base plate

- Before the trigger box is fitted, its base plate must be coated with thermal conduction paste. Only use an appropriate object to apply the paste (screwdriver, matchstick etc.). Thermal conduction paste is not to come into contact with painted surfaces.

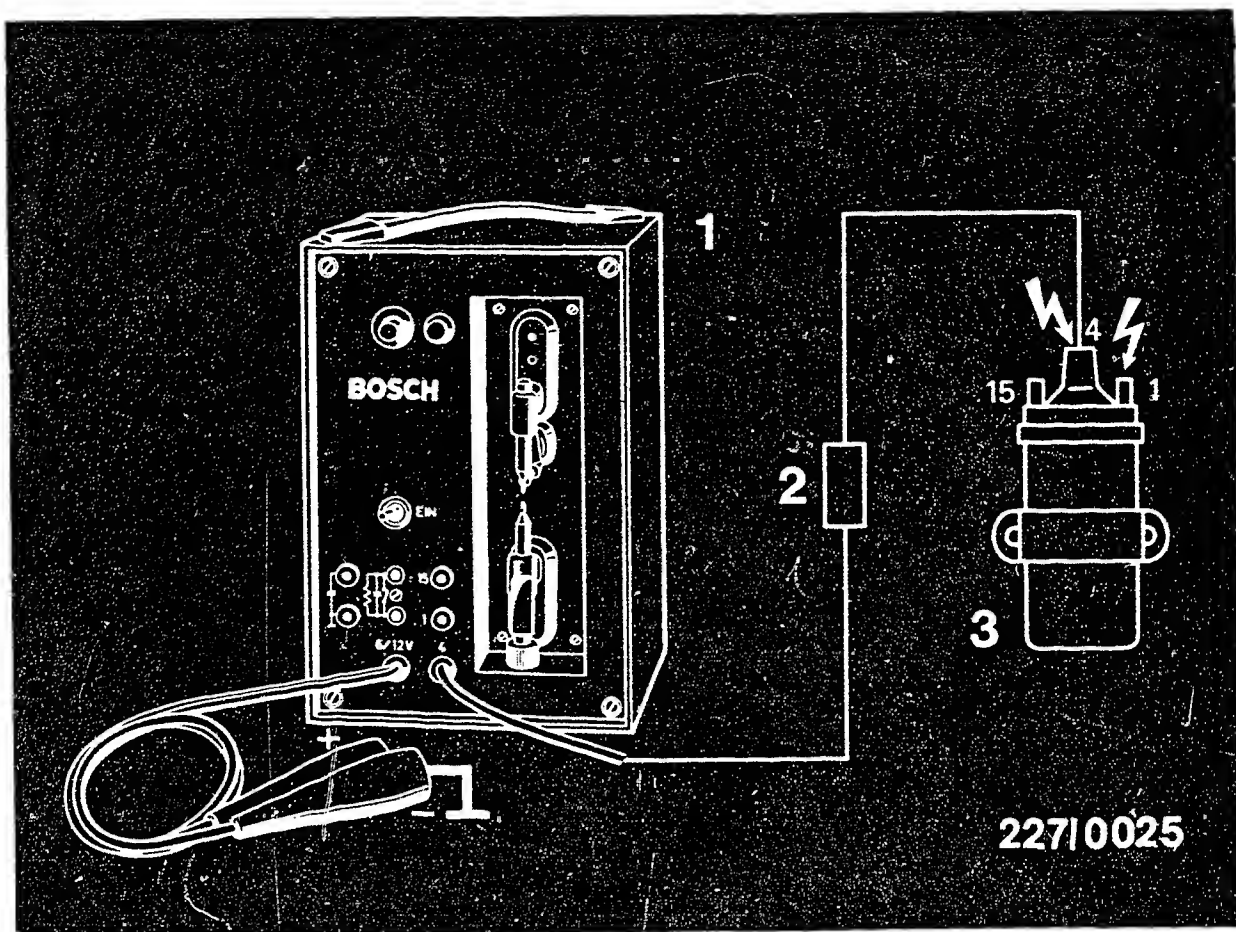
- 1 = Spark gap
- 2 = 5 kΩ sleeve-type suppressor
- 3 = Ignition coil

- In order to prevent the trigger box from being irreparably damaged, when using a spark gap, an interference-suppression resistor of at least 2 kΩ must be connected between the spark gap and ignition coil terminal 4, e.g. sleeve-type suppressor (5 kΩ) 0 356 500 001.
- In the case of ignition distributors with engine-speed limitation the ignition distributor side terminal 4 must have 1 kΩ interference suppression.
Operation without interference suppression will lead to the destruction of the trigger box.

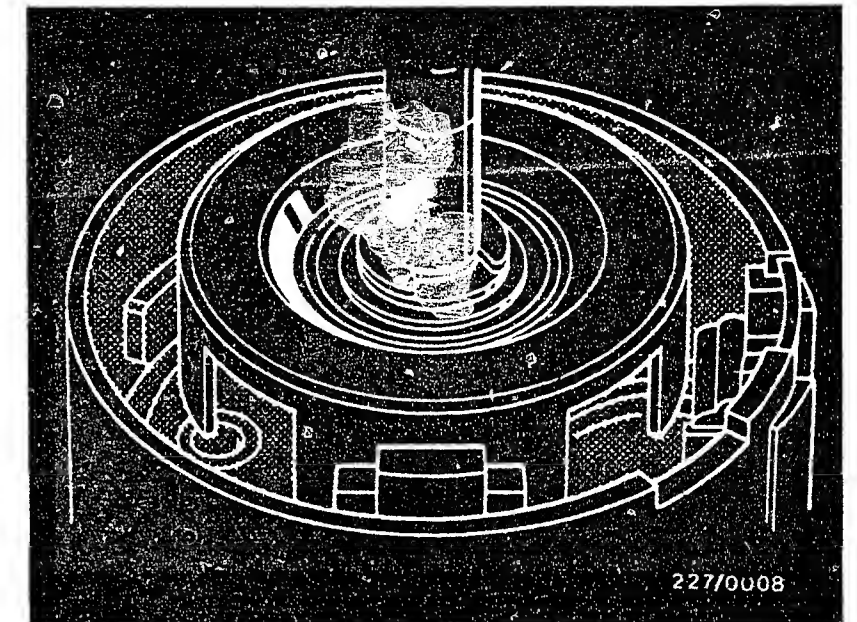
227/0008

Test peak-coil-current cut-off. Connect voltmeter to ignition coil term. 15 and term. 1. Remove distributor cap, distributor rotor and dust-protection cover.

Turn engine over by hand in direction of rotation until vane is completely in air gap of magnetic pickup assembly.

Voltmeter deflects slightly (approx. 5 V) for approx. 1 sec. Voltmeter must return to 0 V..

Voltage (0 V) correct?

Replace trigger box and ignition coil.

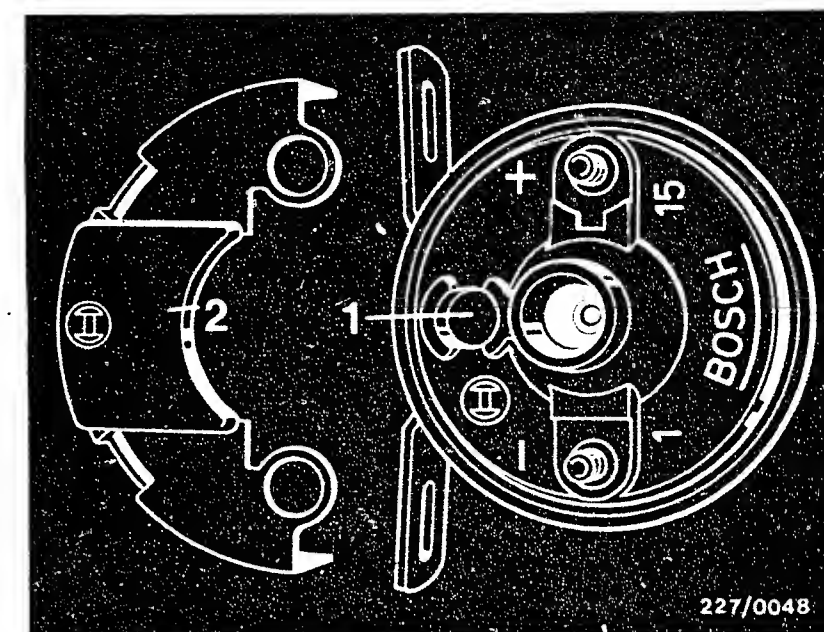
1 = Plug
2 = Protective cap

Visual examination: Remove protective cap from ignition coil and check whether plug (see illustration) is in position and whether any sealing compound has escaped.

Plug in position? No sealing compound escaped?

1. If plug is not in position and/or sealing compound has escaped, replace trigger box and ignition coil:

2. If resistance values are not O.K., replace ignition coil.

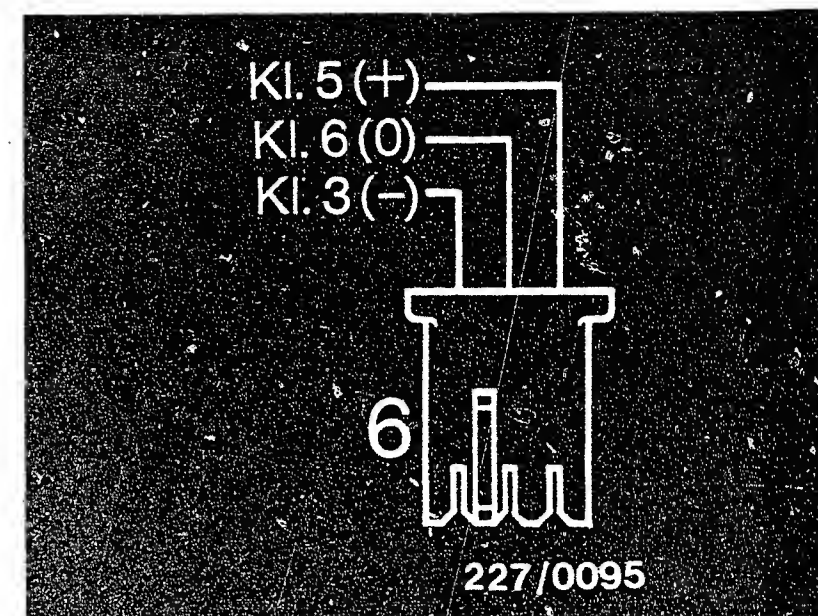
Connect the trigger-box plug and the ignition distributor plug. Push back the rubber sleeve from the ignition distributor plug. Connect the voltmeter with test prods to terminals 5 and 3. The voltage shown may be 1.0 V to max. 3.5 V below battery voltage.

Voltage value O.K.?

Replace trigger box.

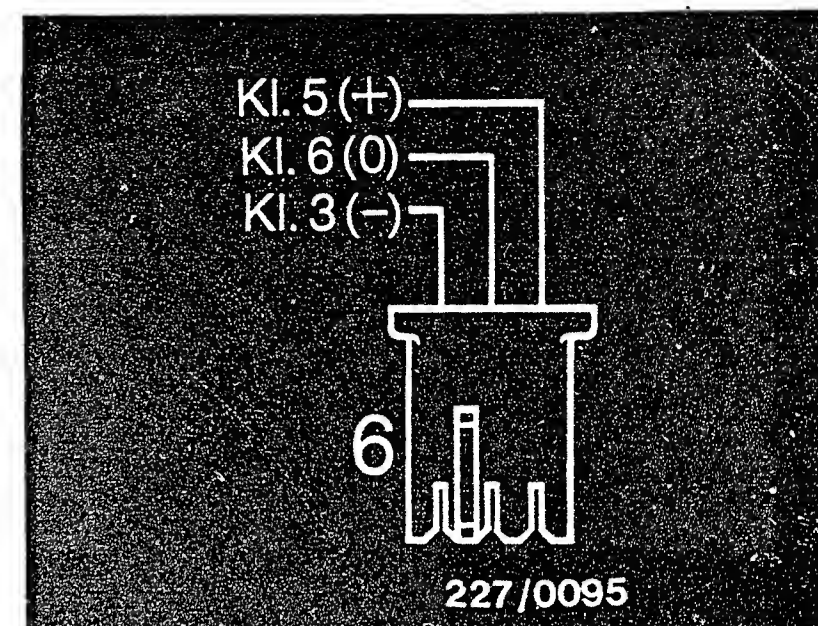
Connect red terminal with test prods to ignition distributor plug terminal 6 (measuring signal). Connect the black terminal to vehicle ground. Start the engine. The oscilloscope must show a rectangular impulse. See illustration.

Is there a rectangular impulse?

Replace pickup assembly or ignition distributor.

Replace trigger box.

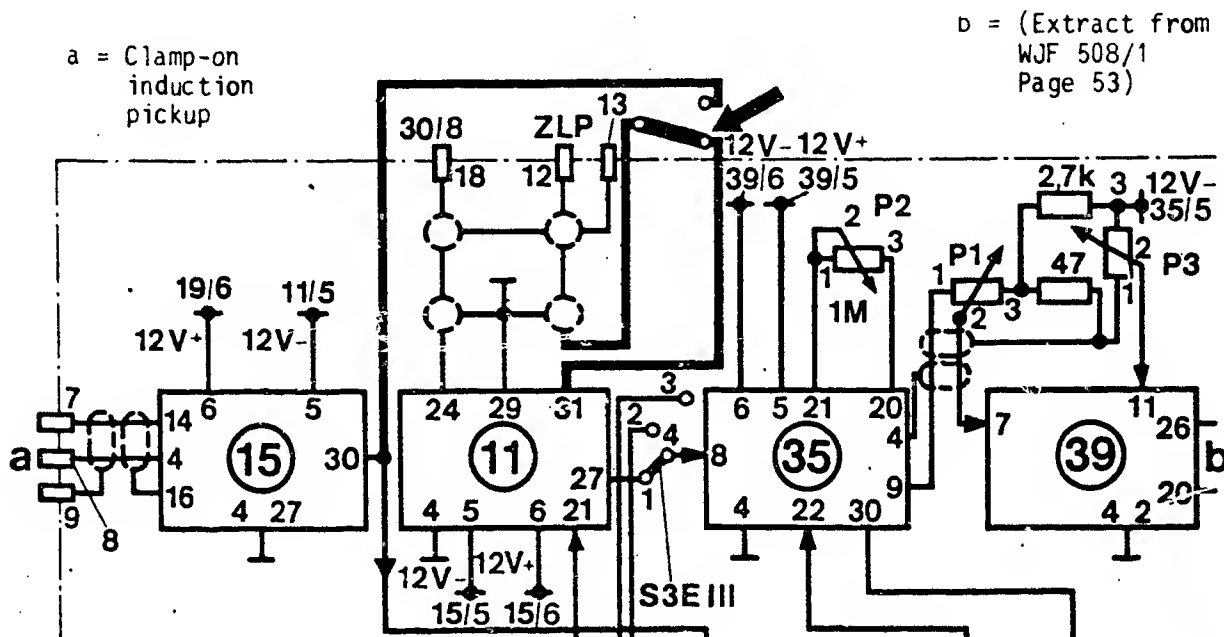
EFAW 214 B

Remove the line of the ZLP* from pin 31 of printed board 11 (coupling stage) and connect to pin 30 of printed board 15 (pulse shaper stage) via a switch with change-over contact (e.g. 0 341 500 803). In addition, a new line must be connected from pin 31 of printed board 11 to the other contact of the switch with change-over contact. Arrow points to switch with change-over contact.

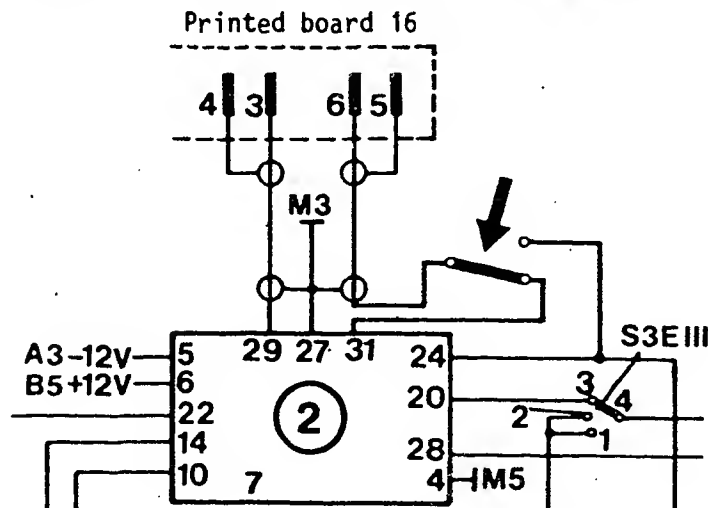
Remove the line from terminal 6 of printed board 16 to pin 31 of printed board 2 (coupling stage) and connect to pin 24 of the same printed board via a switch with change-over contact (e.g. 0 341 500 803). In addition, a new line must be connected from pin 31 of printed board 2 to the other contact of the switch with change-over contact. Arrow points to switch with change-over contact.
